Manhole Inspection Summary

Manhole # S31A__037MH

Insp Date: **12/21/07 10:59 AM**

Location Address: **547 ORCHARD ST**

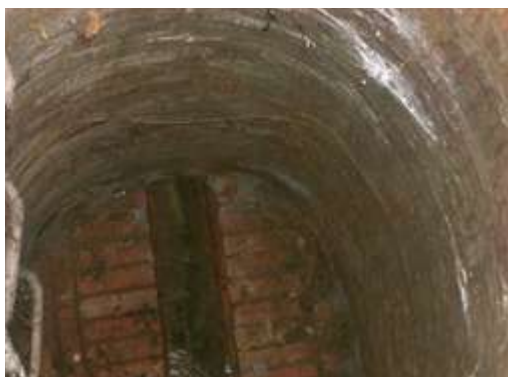
Defect 3

Condition: ☐ Sound ☐ Cracked ☒ **Root Intrusion** ☐ Loose Brick ☐ Deteriorated

ROOT INTRUSION ON BARREL

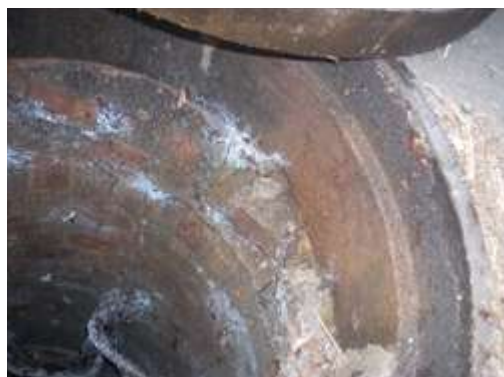
Defect 2

Condition: ☐ Sound ☐ Cracked ☐ Root Intrusion ☒ **Loose Brick** ☐ Deteriorated

LOOSE CHIMNEY BRICKS

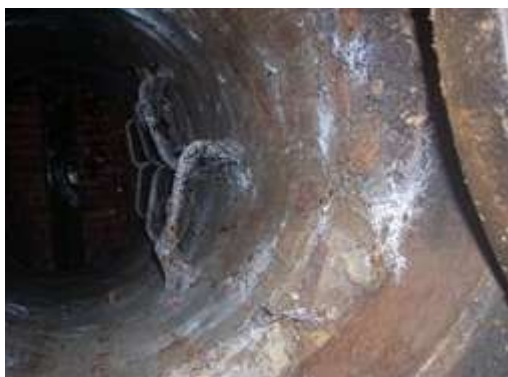
Defect 1

Steps Count: **6** Missing: **0** ☒ **Corroded**

CORRODED STEPS

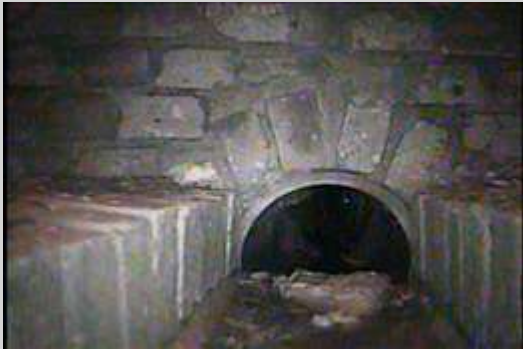
12 O'Clock Outflow

8 in. Circular Gravity Sewer
Pipe Out @ 12 O'Clock

Pipe Height: **8.4** (in.) Rod and Bar (Angled)
Pipe Material: **Clay** ☐ Pipe Lined
Invert Depth: **11.33** (ft.) Flow Characteristics: **Slow**
Deposits: ☐ None ☐ Mud ☒ **Sludge** ☐ Debris ☐ Grease
Silt Depth: **3** (in.) Deposits Extent: **Medium**
Infiltration: **None** Pipe Seal Cond: **Sound**

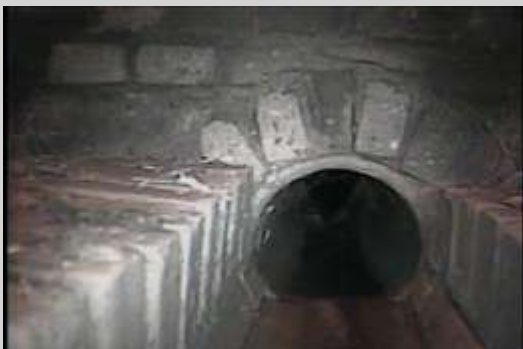
6 O'Clock Inflow

8 in. Circular Gravity Sewer
Pipe In @ 6 O'Clock

Pipe Height: **8.4** (in.) Rod and Bar (Angled)
Pipe Material: **Clay** ☐ Pipe Lined
Invert Depth: **11.17** (ft.) Flow Characteristics: **Slow**
Deposits: ☒ None ☐ Mud ☐ Sludge ☐ Debris ☐ Grease
Silt Depth: (in.) Deposits Extent:
Infiltration: **None** Pipe Seal Cond: **Sound**
